Harrison Tower
1621 Harrison Street
Oakland, CA

Initial Needs Assessment Report

August 20th, 2019

Saida + Sullivan Design Partners, Inc

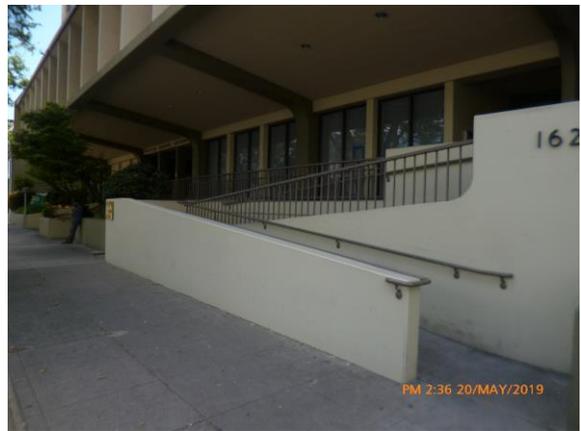
Driveway, Building Sign, Stair, Planters

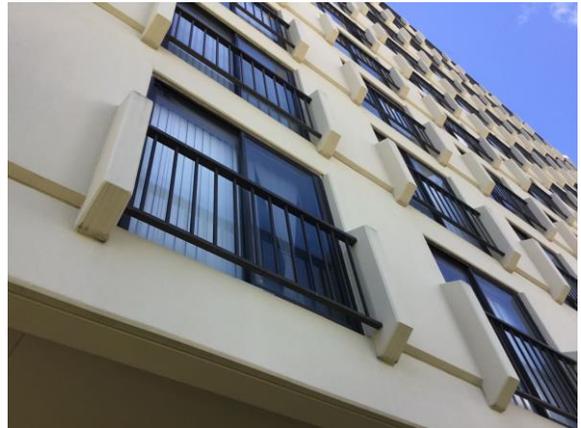
Comments: Due to age, the sliding function may not be smooth. Single pane windows with thermally un-insulated frames are very ineffective for energy performance and conservation and replacing the windows with ones with better thermal performance is recommended.

Typical Exterior wall, Windows

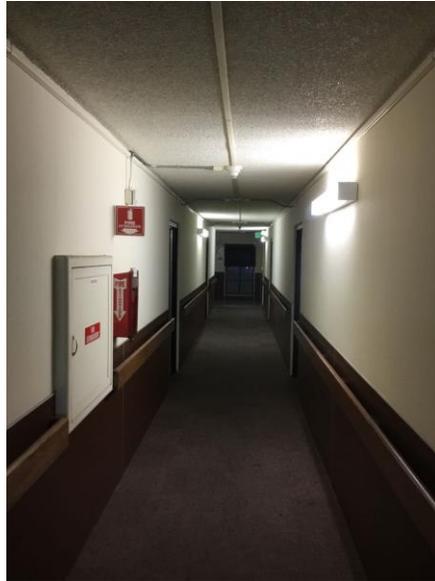
Upper Floor Corridor

Comments: The corridor finishes (carpet, wall finish) appear to be in poor to fair condition. Corridor flooring, base and either the wainscot or lean rail should be considered for replacement. Currently the lean rail and wainscot are the same color making the lean rail difficult to identify where it is. In general the corridors are dark (dark carpet, wainscot, front doors). Consideration for more contrast and lighter finishes in the corridors as a strong visual, as well as varying them per floor for way finding. The conduits for the fire alarm system and security system are exposed in the corridor, but concealing the conduits will require a dropped ceiling and it is not recommended. Painting of all exposed conduit is recommended. Unit ID numbers are on the entry door. It is recommended that new Unit ID signage be provided on the adjacent wall with code required braille. Additionally, from the elevator lobby unit directional signage is recommended.

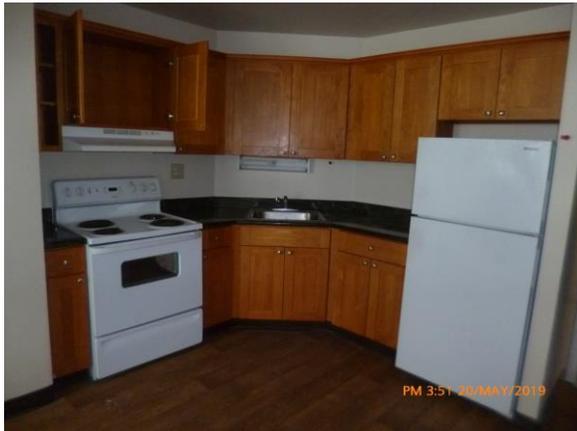
Unit 408 Kitchen

Comments: With the exception of just a few units, the existing cabinets seem to be at the end of their useful life and are recommended to be replaced with new that have wire pulls for hardware.

Comments: The laminate countertops are at the end of their useful life and are recommended to be replaced. The granite countertops in general were in good condition and possibly could be re-used. The wear on the sinks varied across units as well. It is recommended to replace them as budget allows.

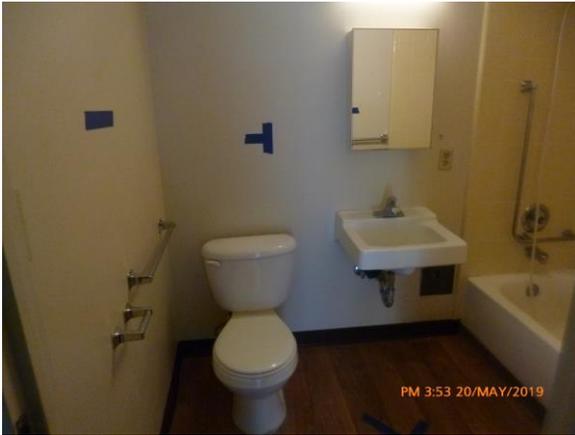
Unit 408 Bathroom

Comments: The condition of the bathrooms vary widely. Some tub/shower installs are stained and moldy, while some are clean and are in good condition. A few showers were observed but have shower pans that are 2-3" above the floor and would not meet accessibility codes.

Condition of the flooring, sinks, vanities and toilets varied from unit to unit. It is recommended to replace all bathroom fixtures with low flow fixtures, and replace finishes since all units only have only one full bath, it should be in the best working order possible. Also recommended is consideration for grab bars in bathrooms given the aging population (and not above towel bars).

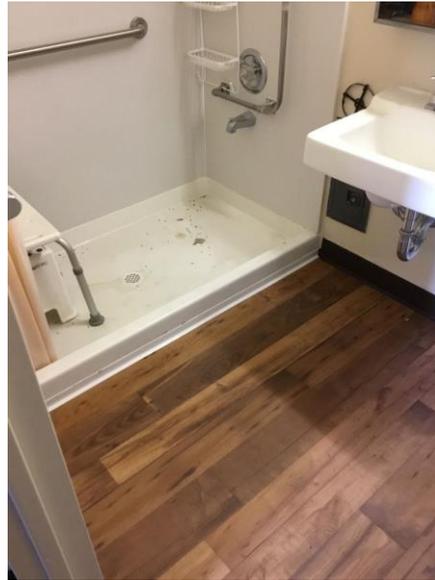
Unit 601 with shower pan

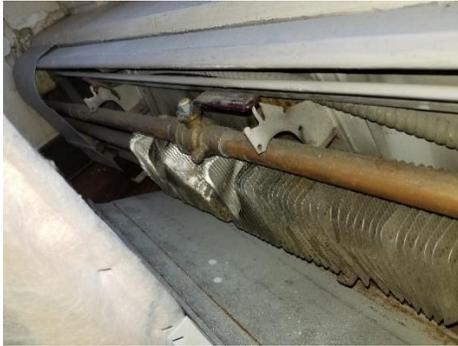
Typical Convactor Condition, Bent Fins

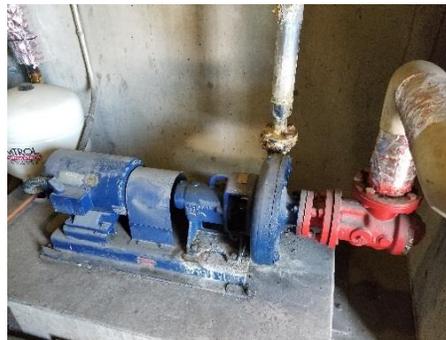
Heating Water Pump showing Corrosion

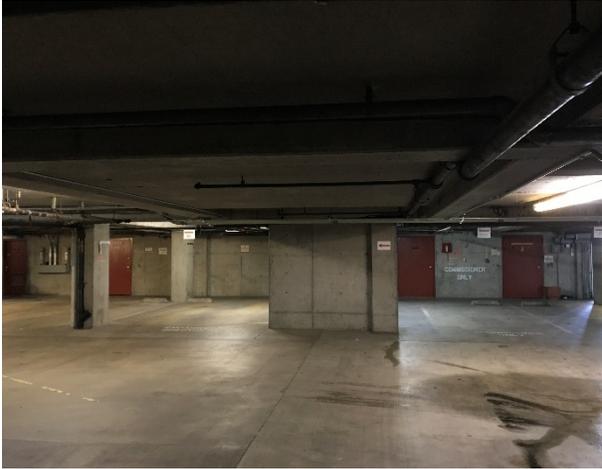
Building Basement & MEP Bracing

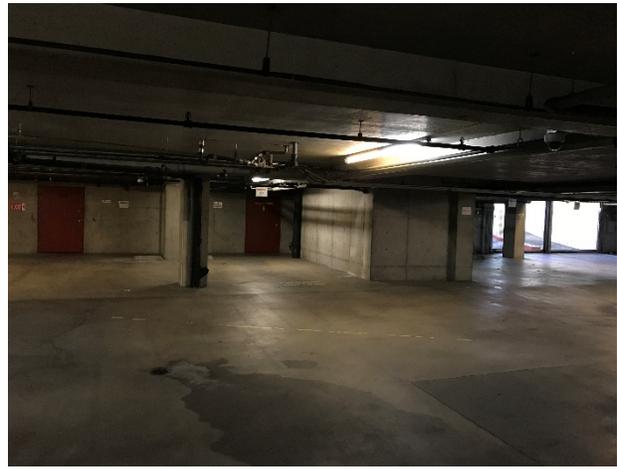
Building Basement & MEP Bracing

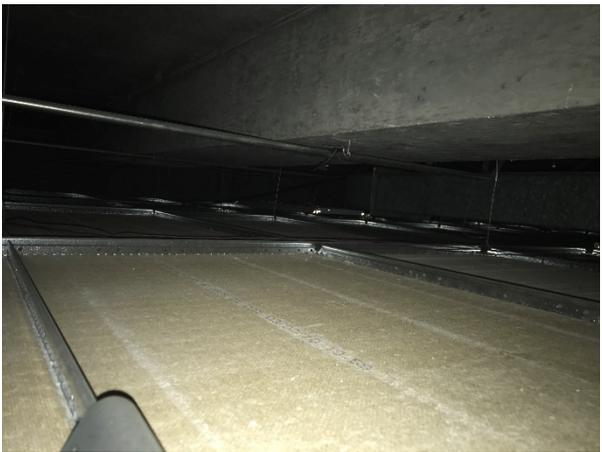
Third Floor Suspended Ceilings with Wire Bracing

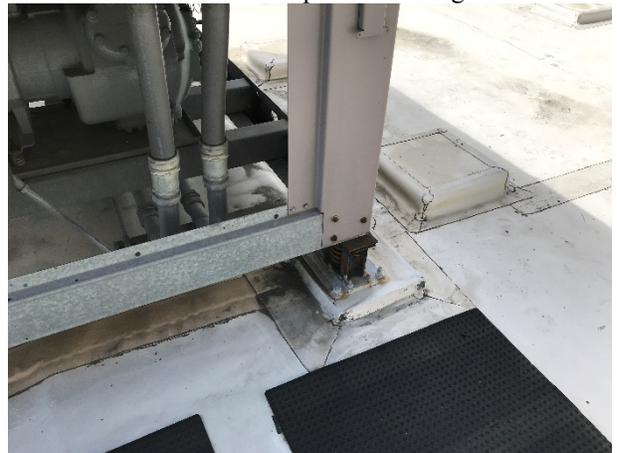
Third Floor Roof mounted equipment anchorage

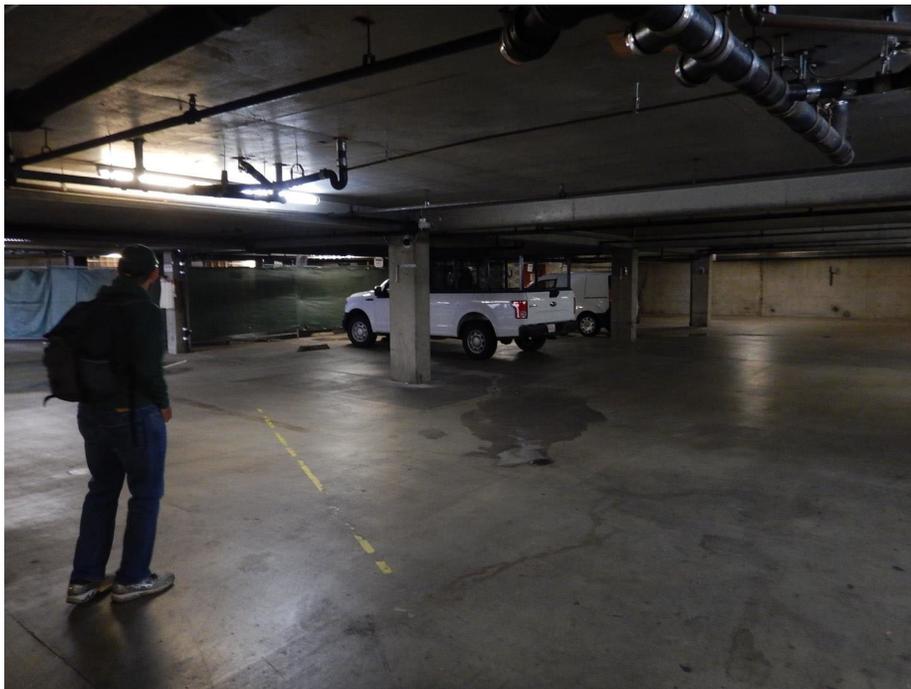
Photo 2: Leakage in garage.

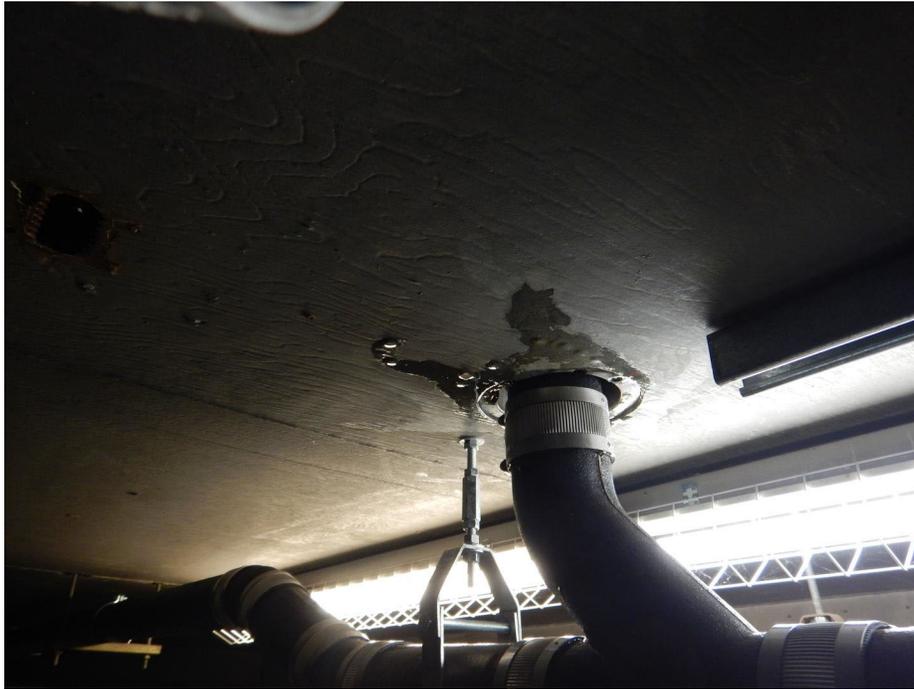
Photo 3: Leakage in garage.

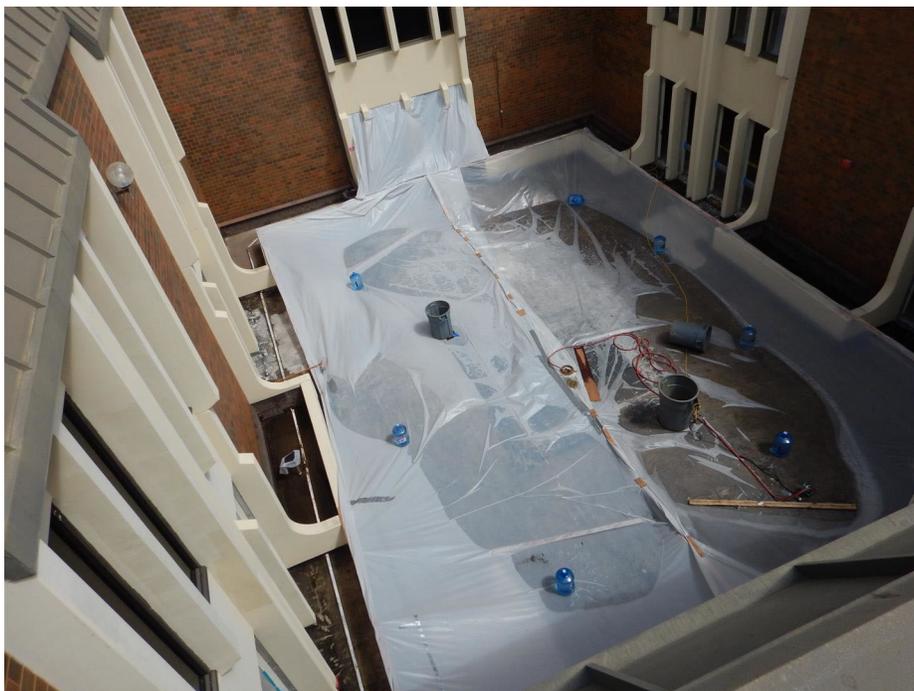
Photo 4: In-progress courtyard work above leaks.

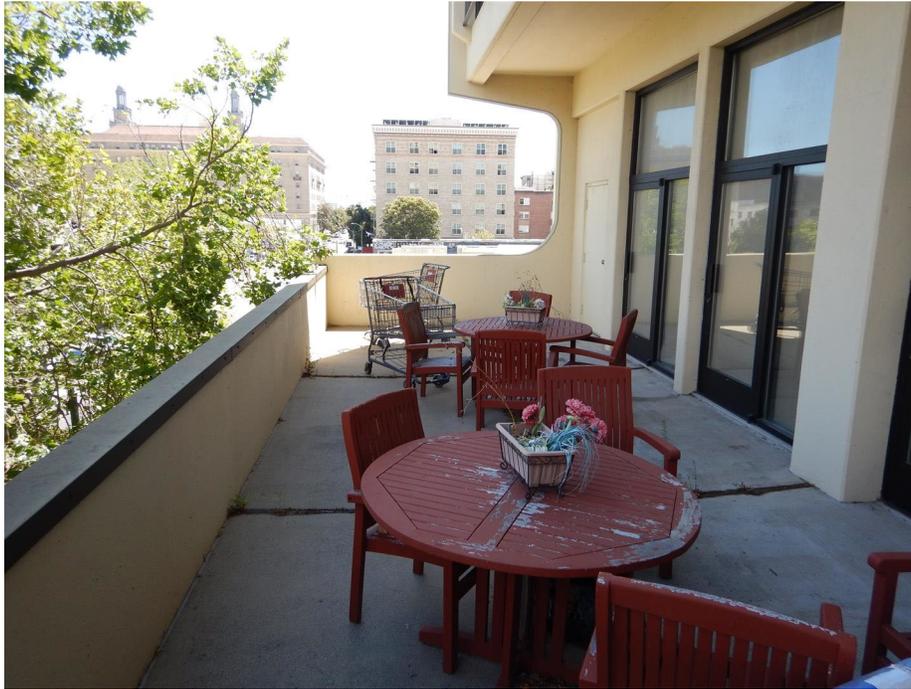
Photo 5: Level 3 deck. Note vegetation grown.

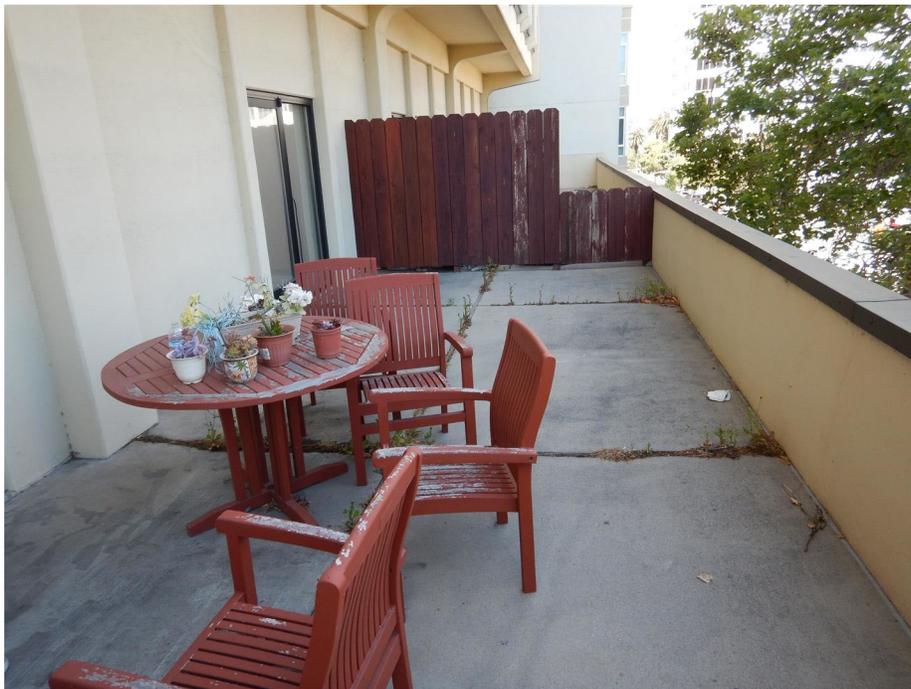
Photo 6: Level 3 deck. Note vegetation growth.

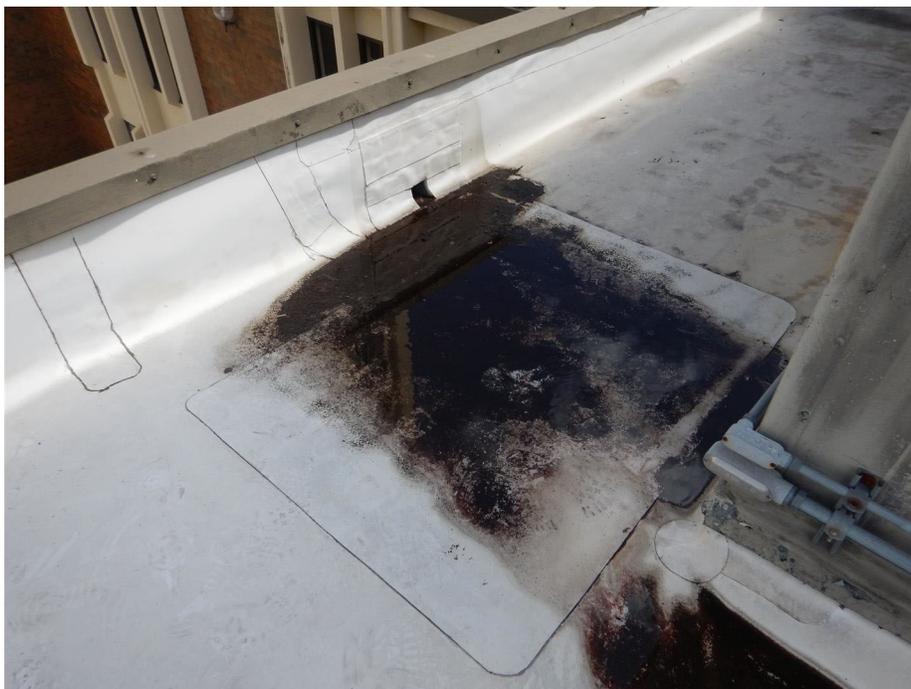
Photo 12: Ponded water at Level 3 roof.

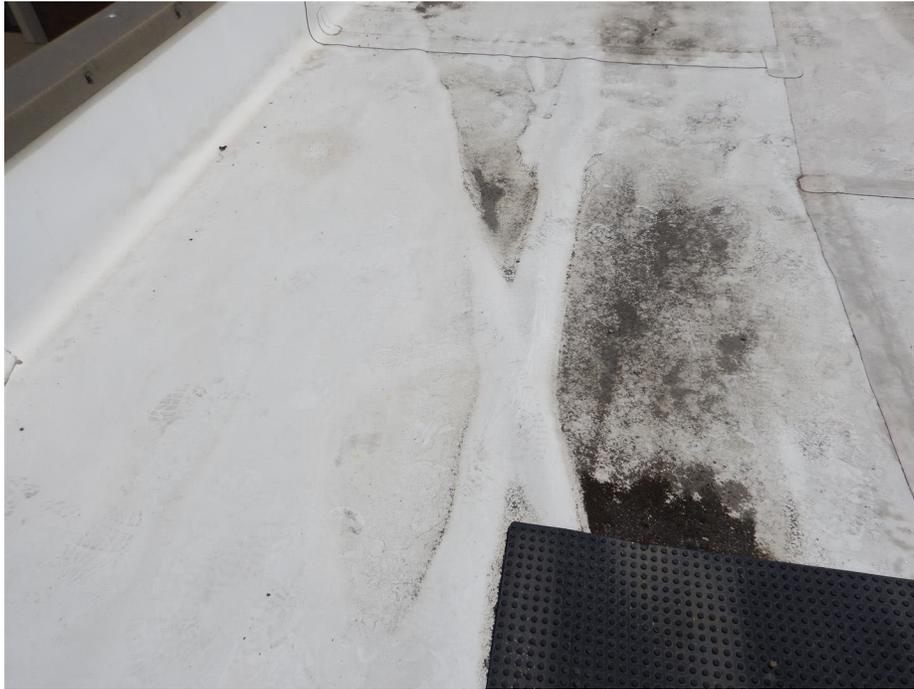
Photo 13: Blisters in Level 3 single-ply roof membrane.

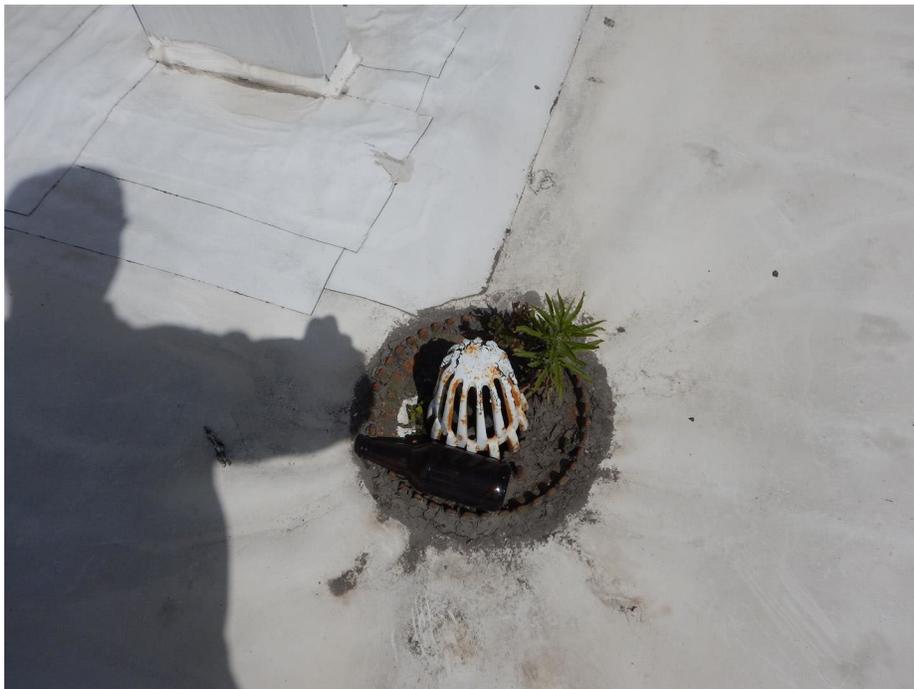
Photo 14: Plant growth at Level 3 roof.

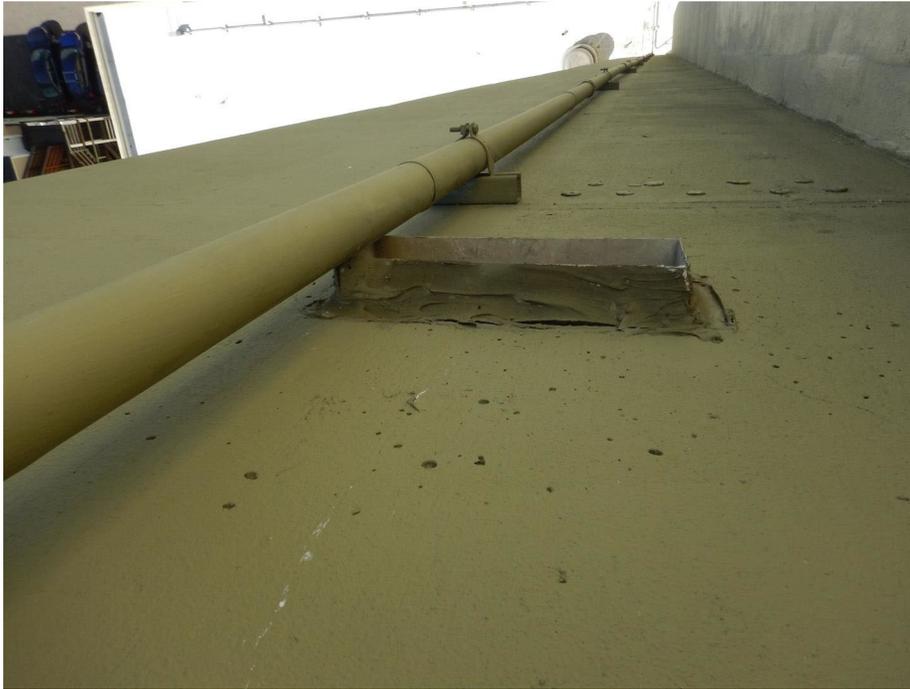
Photo 19: Typical scupper on main roof. Note weathered sealant.

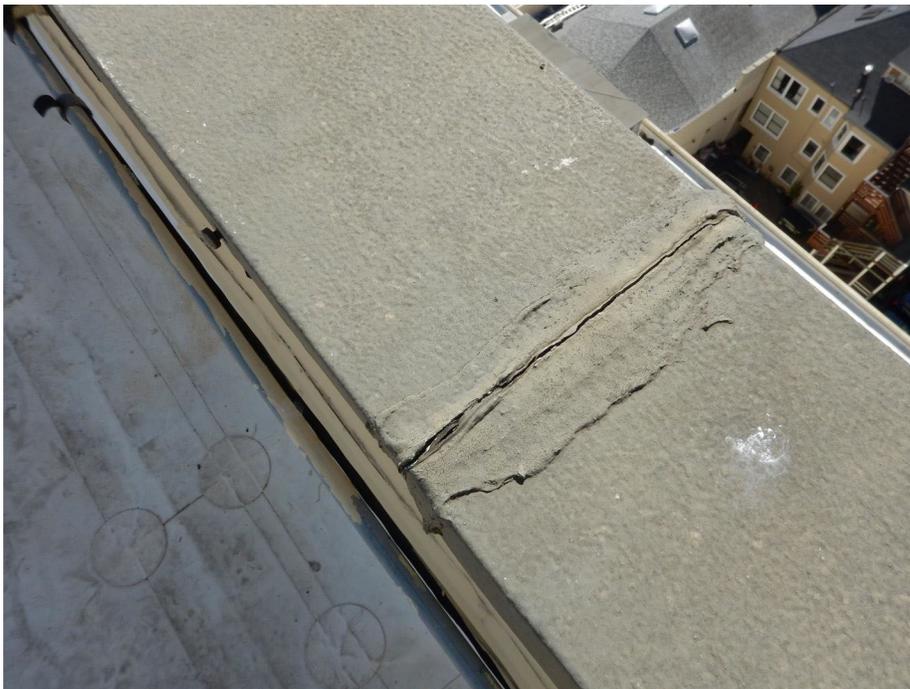
Photo 20: Split sealant at parapet joint.

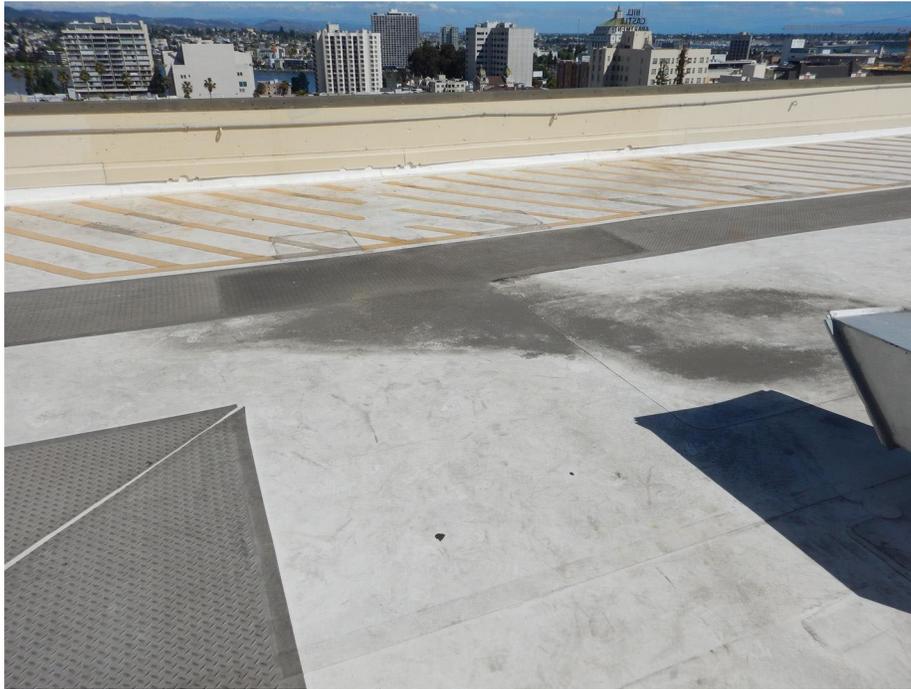
Photo 21: Ponding stain on main roof.

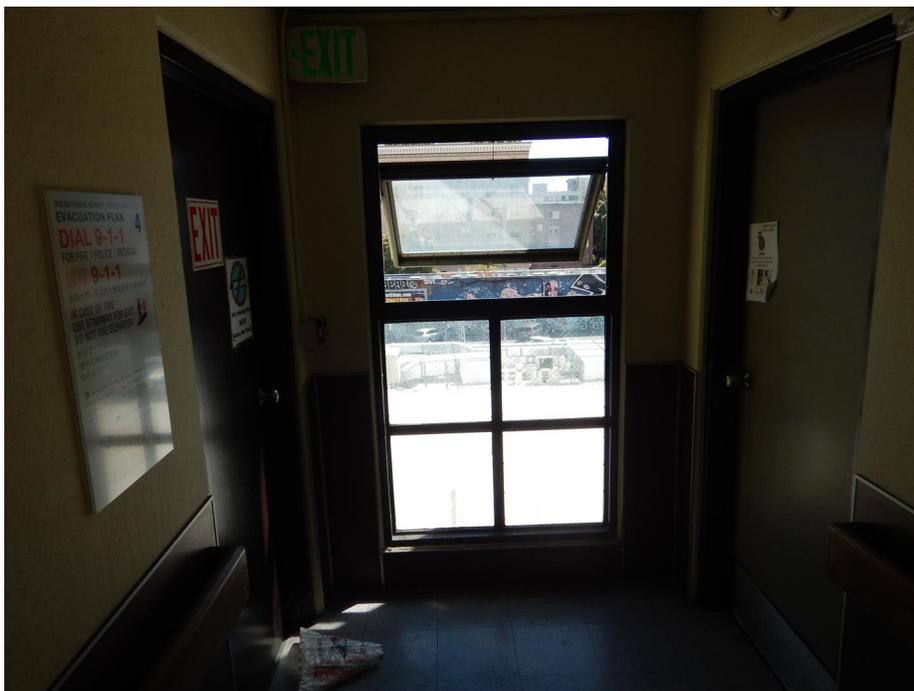
Photo 26: Level 4 corridor window. Note deteriorated sealant.

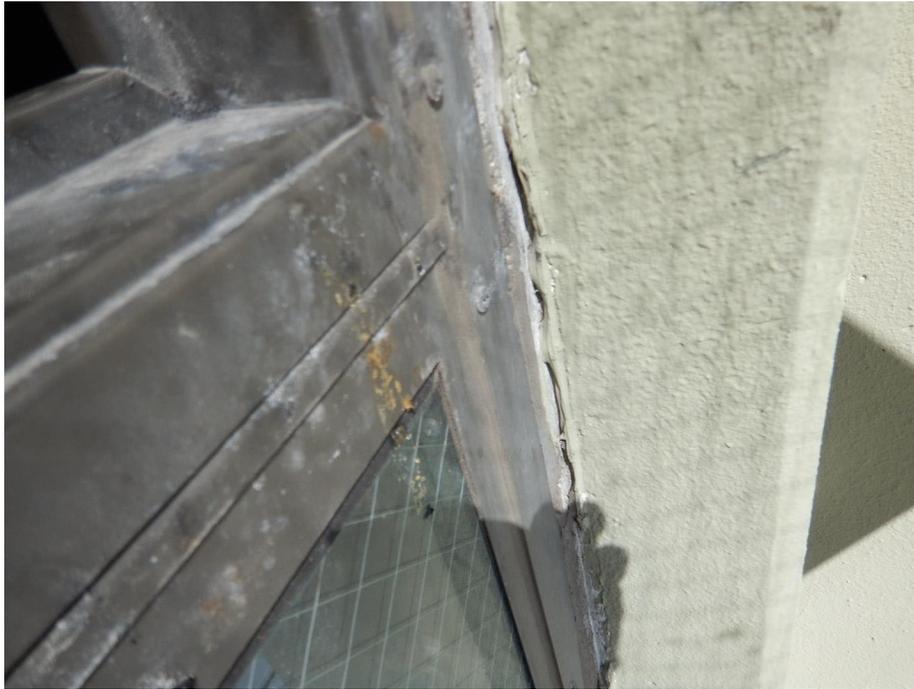
Photo 27: Level 4 corridor window. Note deteriorated sealant.
