Seismic Risk Assessment of building at 1621 Harrison Street, Oakland, CA

PML REPORT

2019 September 30

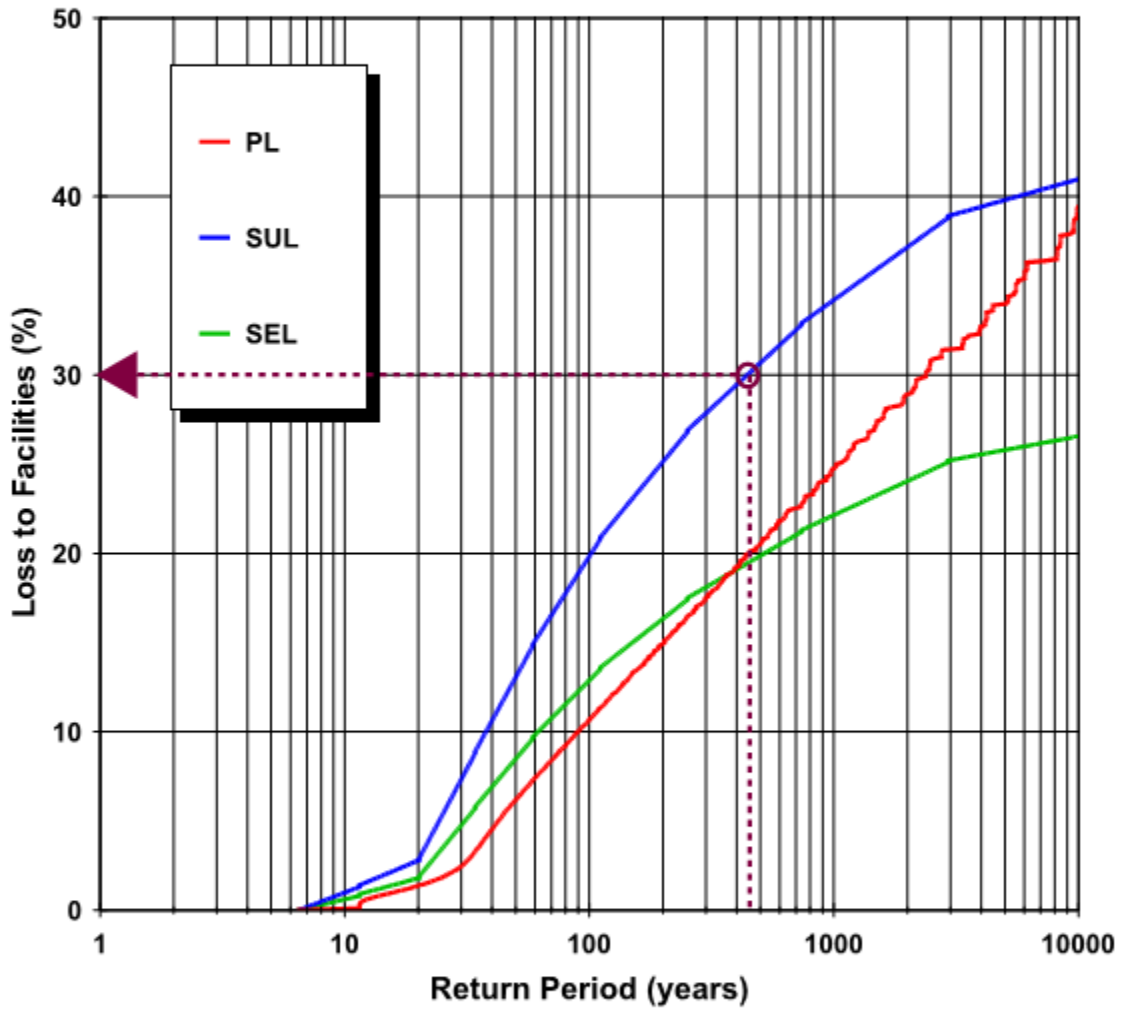
Figure 7. Determination of PML for the Building

The seismic risk of the building is judged moderate with a PML of 30%. The higher PML for this building is not unexpected because:

The PML (90% percentile for 475 year earthquake) for the Building was determined to be 30%; see Figure 7.

To reduce the PML below 20%, there are robust and cost-efficient options available that have been used to seismically retrofit similar types of buildings in the past. The goal of a successful upgrade is to mitigate the key deficiencies in an efficient manner while staying cognizant of the need to minimize retrofit costs and maintain building occupancy. We have taken the step to prepare a mathematical model to simulate the building performance based on available as-built drawings, these are steps consistent with a Tier 2 analysis. An initial step to help lower the PML would consist of a more detailed structural assessment of the existing building condition through material testing and soils investigations at the site. The outcome of this step would help identify the key deficiencies that need to be addressed, confirm our analysis assumptions, more accurately predict material strengths, and verify as-built details not presented in the as-built structural drawings. After a more detailed material testing and soil investigation, the PML could be reduced, although we don't anticipate it would lower the PML below 20%. We believe strengthening of existing columns,

beams, and walls, adding shotcrete walls, and floor strengthening to eliminate expansion joints at the podium would bring the PML below 20%. Adding shotcrete walls could come in the form of replacing non-structural partitions with shotcrete walls where vertical discontinuities exist in the lateral system. In appendix A.6 of this report, conceptual details and plans are provided to help with understanding what these retrofits look like, the PML associated with these concepts are provided in appendix A.7. The conceptual details and plans provided are considered a conservative design. Progressing the conceptual design to a construction document would entail more detailed analysis and offers the possibility of a reduced number of concrete walls necessary to retrofit the building. We want to emphasize that all details are conceptual in nature, not final retrofit solutions, and any pricing generated based on these details should incorporate a sufficient amount of contingency.

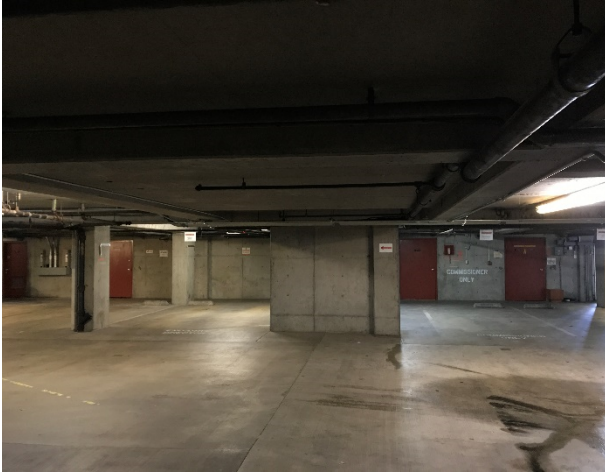
Building Basement & MEP Bracing

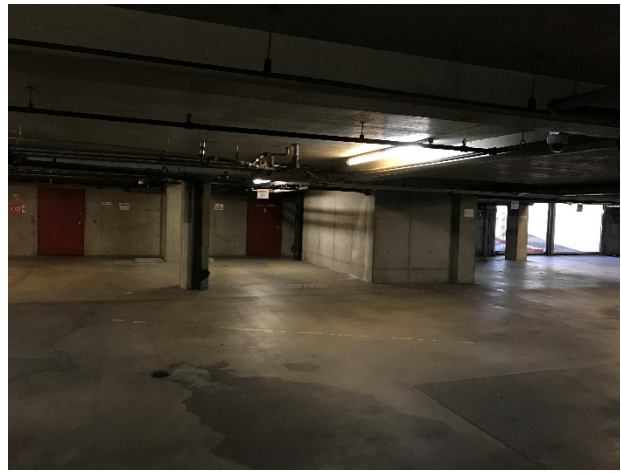
Building Basement & MEP Bracing

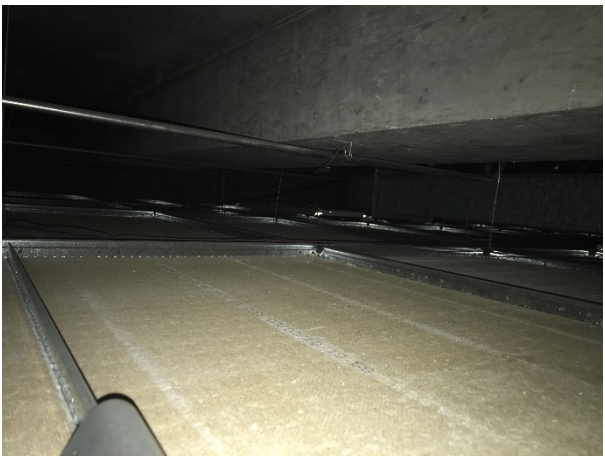
Third Floor Suspended Ceilings with Wire Bracing

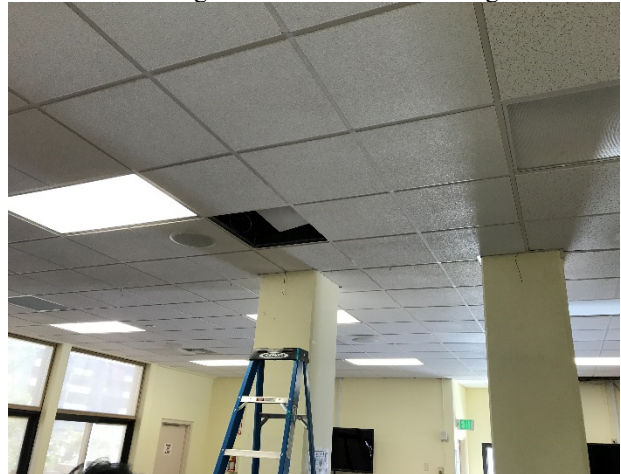
Third Floor Suspended Ceilings

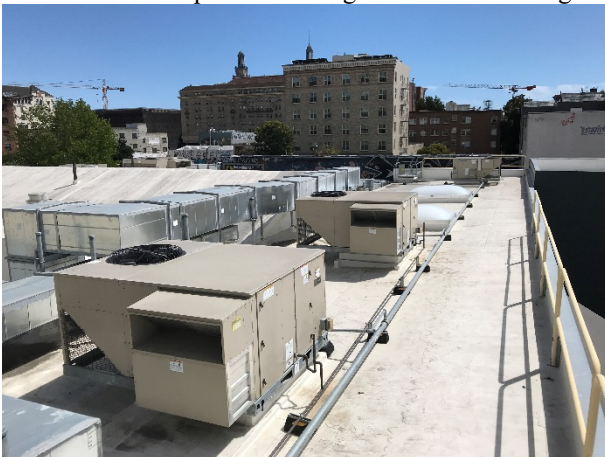
Third Floor Roof mounted equipment

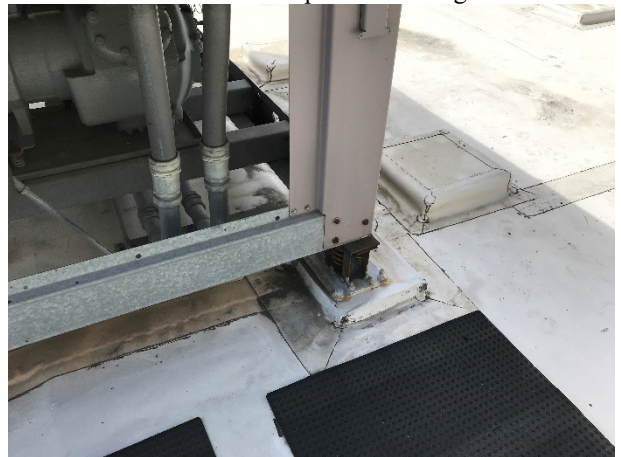
Third Floor Roof mounted equipment anchorage

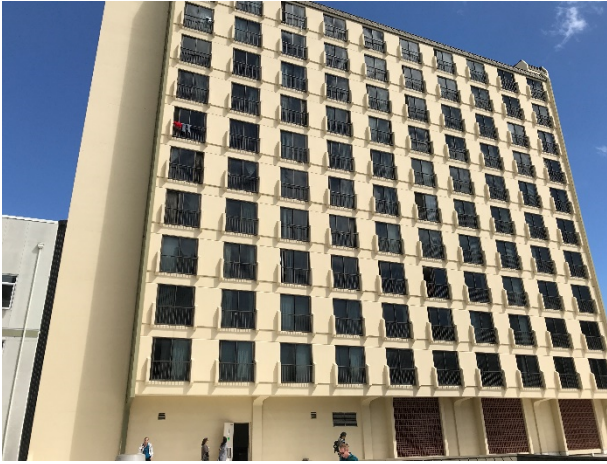
Building Exterior
Figure A.1. Photographs of the building taken during the site visit

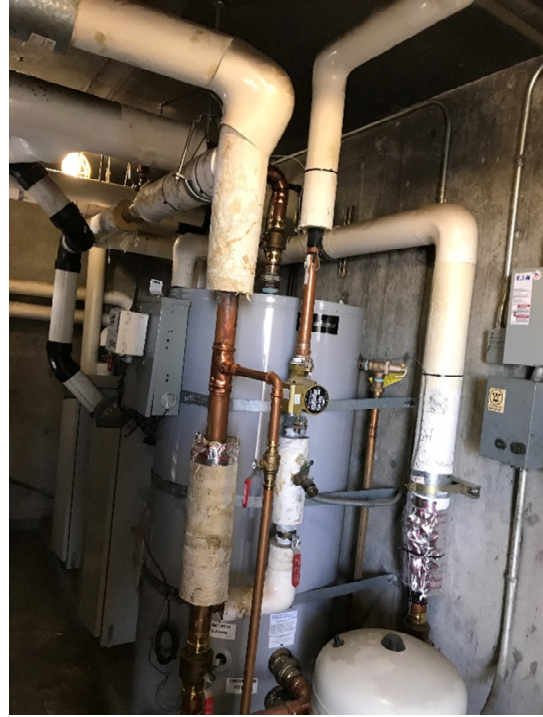
Roof MEP Equipment
