Harrison Tower
1621 Harrison Street
Oakland, CA

Initial Needs Assessment Report

August 20th, 2019

Saida + Sullivan Design Partners, Inc

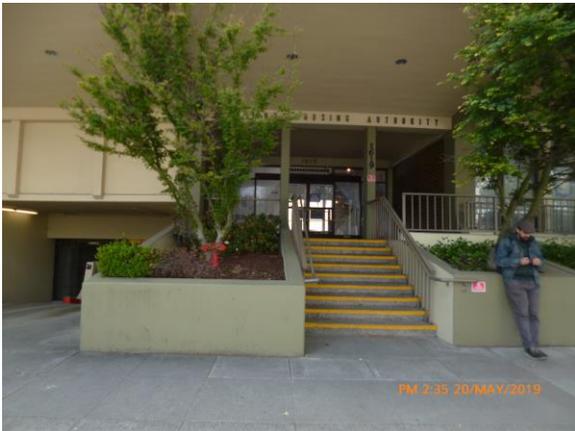
Driveway, Building Sign, Stair, Planters

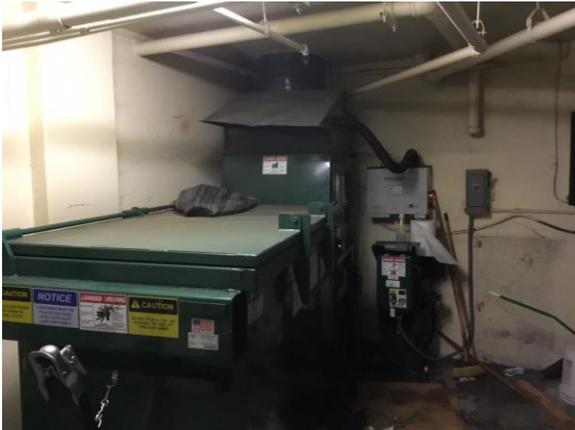
Trash collection room at garage level

The main trash collection room is located in the garage level, and a trash compactor and two trash bins were observed. There is one trash chute connecting thru each floor and down to the main trash room. There is no means of ventilation in the trash rooms including the main trash collection room.

Comments: Review of the trash collection system and ventilation system with the property manager/ owner is recommended.

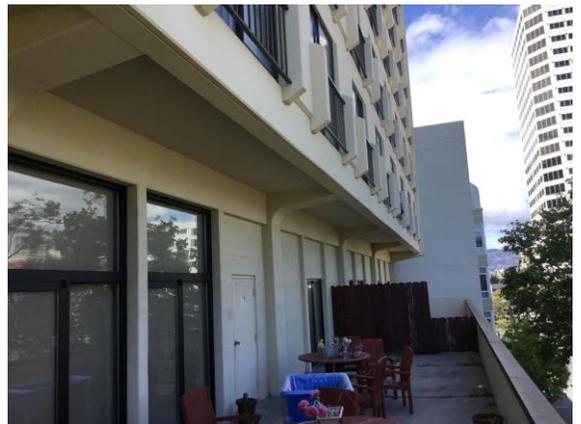
Storefront/ doors at 3rd floor deck

Comments: All doors appear to be in working condition while damage to the finishes were observed. Due to age, replacing all doors should be considered.

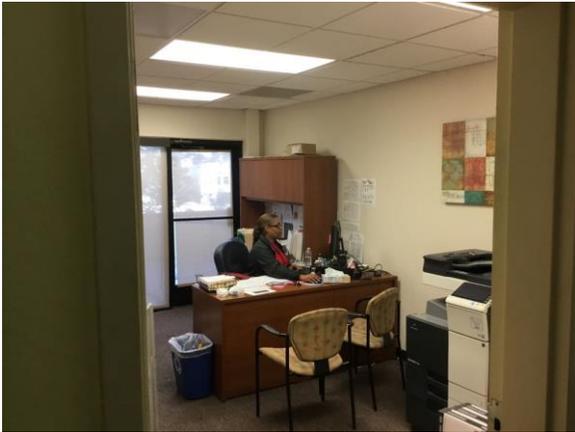
Assistant Manager's Office

Comments: The interior finishes appeared to be in fair to good condition. An interest for repurposing some office spaces was expressed by the Owner during the site visit. Further discussion and study are recommended. All door operating hardware should be lever style.

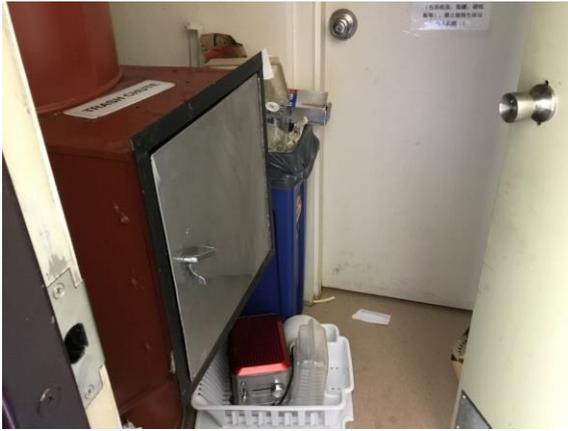
Upper Floor Trash Room

Comments: It is recommended that the functionality of the trash collection is reviewed with the Owner and the property management team.

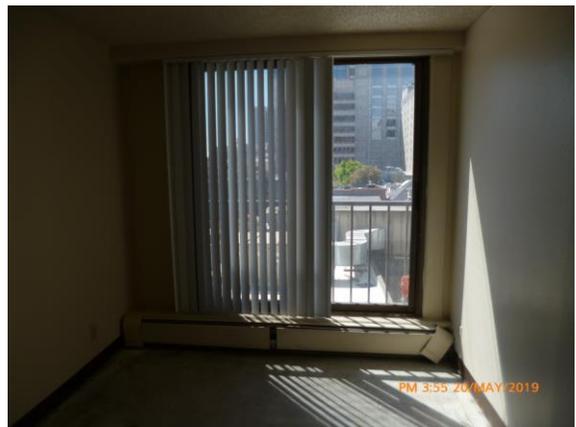
Unit 408 Bedroom with removed carpet

Comments: Flooring is in poor to fair condition. Carpet is less preferred for the use of wheelchairs, walkers, and canes as well as durability (cleaning) and bed bugs. Sheet vinyl is more difficult to repair if damaged in one area. A vinyl plank or tile product with slip resistance, acoustic isolation mat (or integrated cushioned back) is recommended for comfort underfoot, firmness for wheelchairs and walkers, durability in wet and dry areas, and ease of replacement as needed. Elimination of flooring transitions due to differing floor materials (unless a flush transition is used) is also recommended for a senior housing development. Use of low or no-VOC adhesives is recommended for indoor air quality.

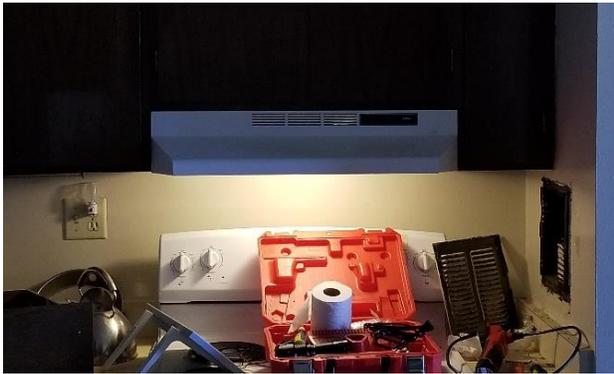
Typical Range with Recirculating Hood and Wall Exhaust

Although the building has a passable subducted exhaust system, it lacks any fresh air supply. Localities and certain zones are moving toward requiring MERV 13 air filtration to protect occupants against poor outdoor air quality. MERV 13 air filtration requires fan-forced supply air flow due to the resistance of the filter.

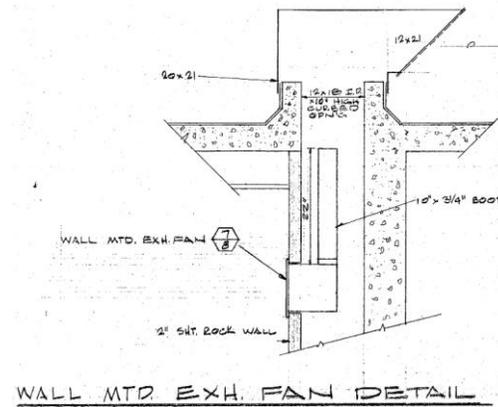
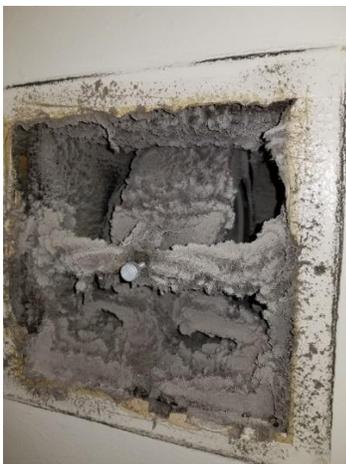
Wall-mounted Bath Fan, showing Dirt

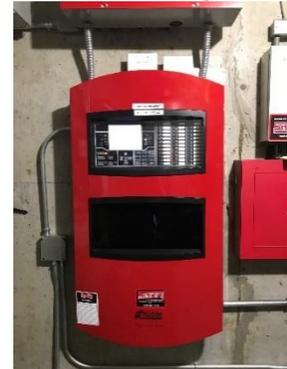
Fire Alarm Control Panel (FACP)

There is an existing hard-wired fire fighter telephone system within the exit stairwells of the building but it is unknown if it currently functions.

There are currently no two-way communication devices and/or an Emergency Radio Responder Coverage System (ERRCS) system provided at the facility for emergency responders.

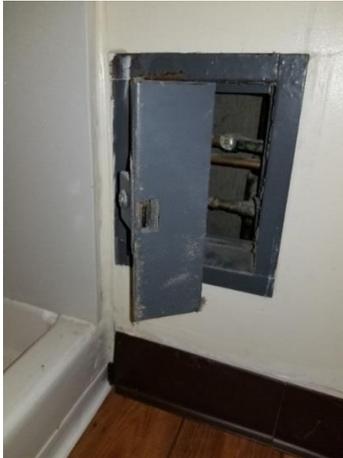
Rated Hatch into 2-hour Shaft, Shut-off Valves

The building has two vertical chases in each apartment. One forms the wet wall of the bathroom, and the other is a corner chase in the kitchen behind the corner-mounted sink. The chases contain cast iron Drain Waste and Vent piping (DWV) and copper hot- and cold-water risers and laterals to the fixtures. All the piping is past its Expected Useful Life (EUL).

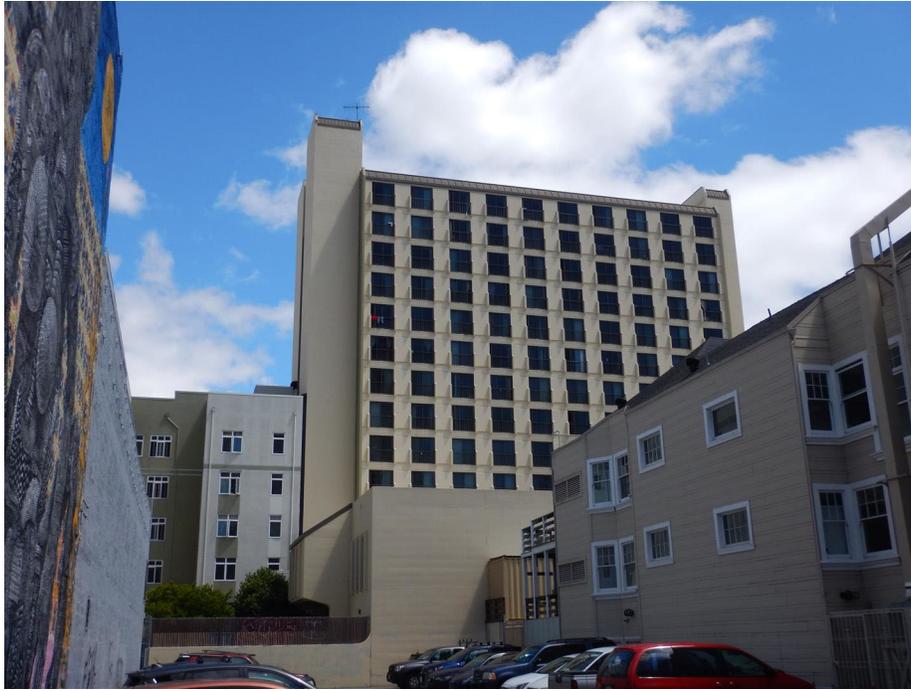
Photo 1: General view of building.

Harrison Tower, a 13-story building containing 101 units of senior housing (Photo 1), is scheduled to be renovated in the near future. We reviewed the Physical Needs Assessment by Dominion Due Diligence Group (D3G). D3G made the following conclusions:

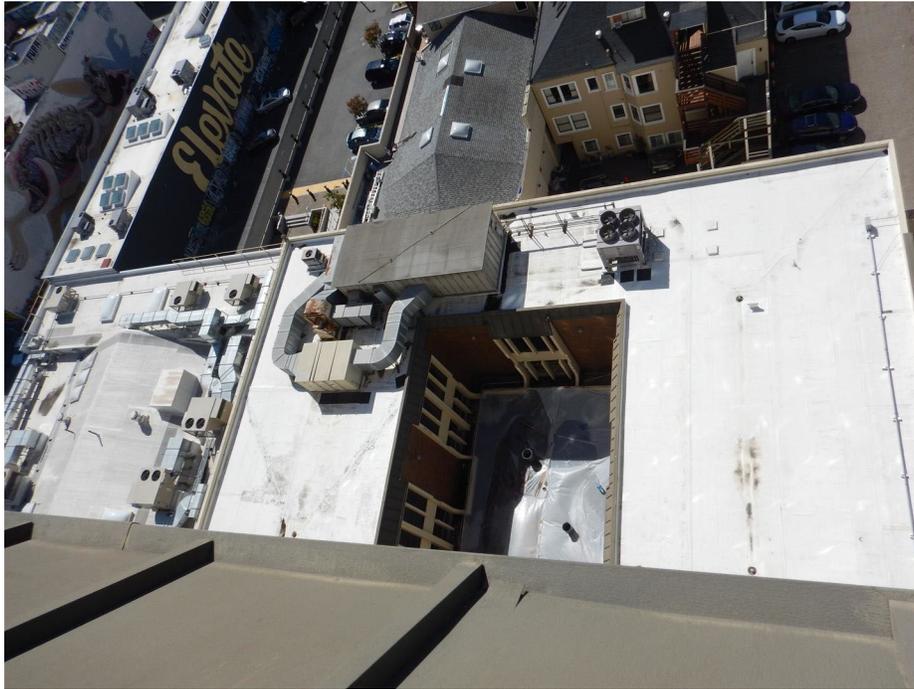
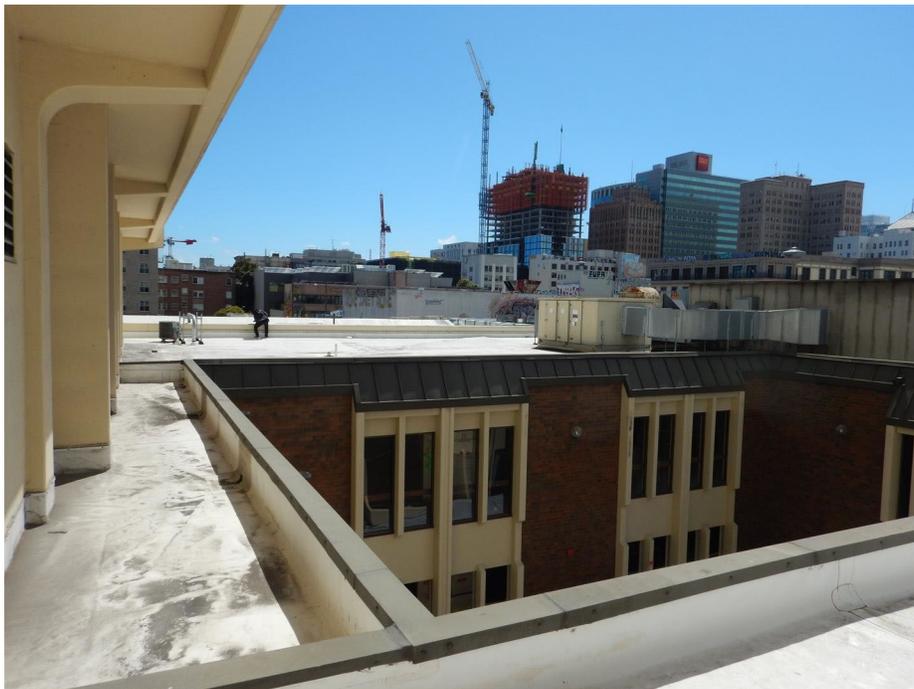
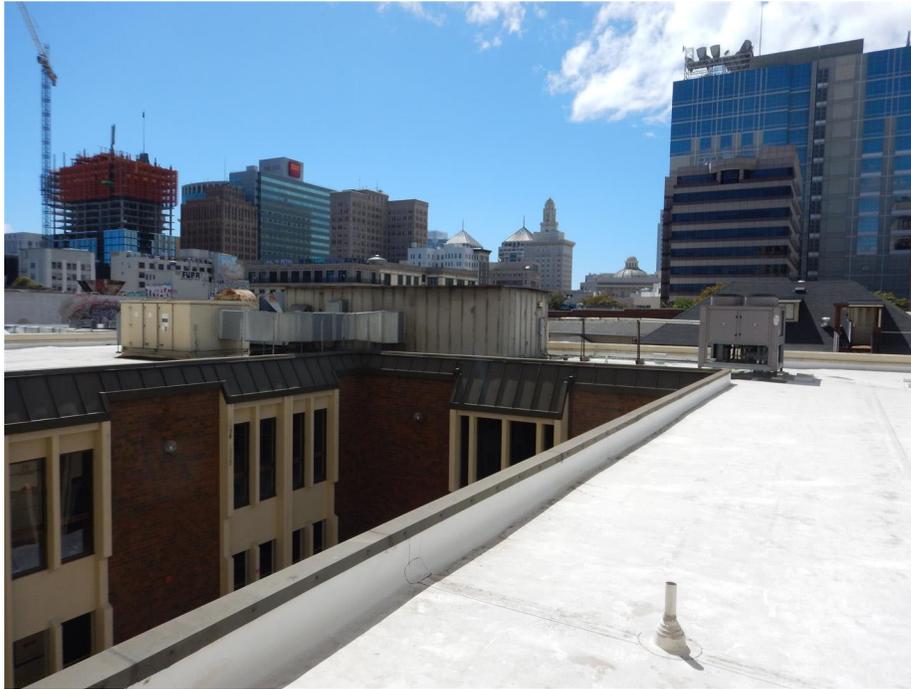
- The roof is located at the rear of the building and has a U-shaped plan (Photos 9 to 11). It is a single-ply roof system bounded by low perimeter curbs and the building wall. There is mechanical equipment at one area of the roof. Roof drains and scuppers provide drainage.
- Ponded water occurs in front of one scupper (Photo 12) and blisters occur at the northwest corner of the roof (Photos 13 and 14); plant growth occurs at one roof drain (Photo 14).
- The roof is accessed from the laundry roof; the single-ply roof continues under the door sill (Photo 15)

Photo 9: Level 3 roof.

Photo 10: Level 3 roof.

Photo 11: Level 3 roof.

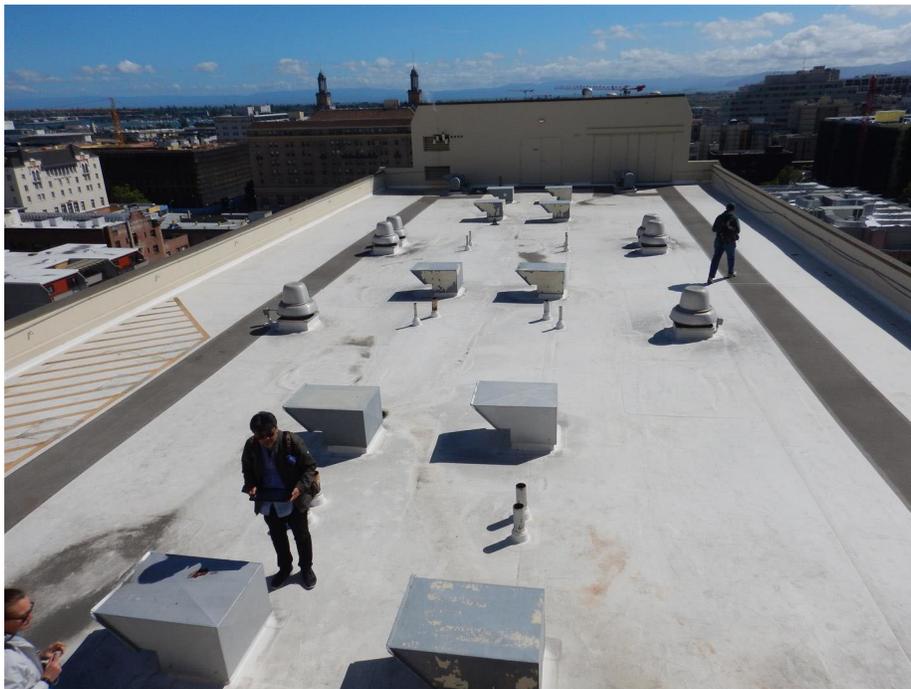
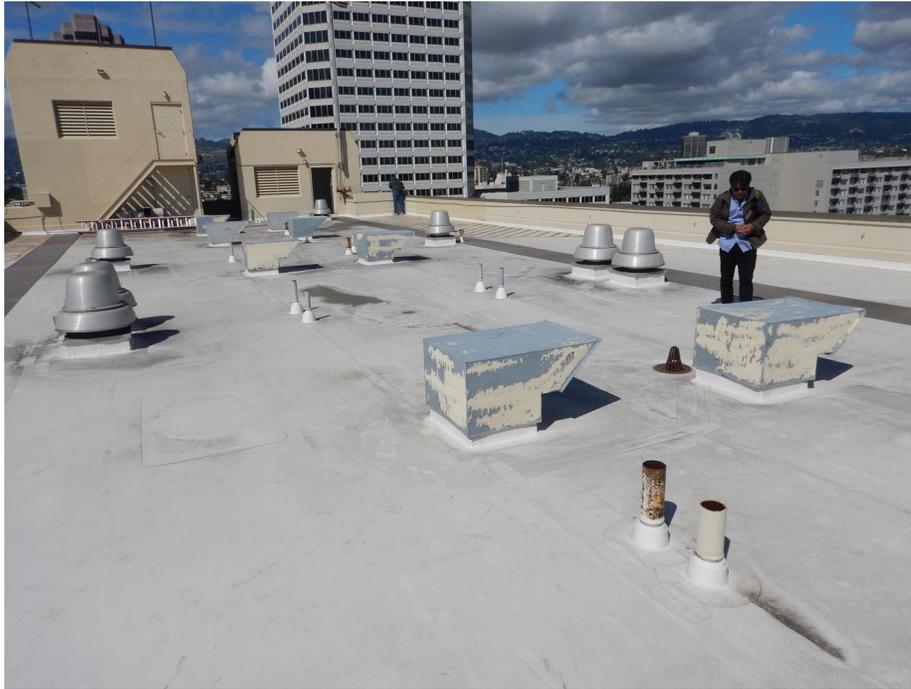
- The roof has a single-ply roof system bounded by parapets and the penthouse building walls (Photos 16 and 17). Roof drains and scuppers provide drainage. Roof penetration include vents and vent pipes (Photo 18).
- The sealant is weathered at scupper/concrete wall junctions (Photo 19). Parapet coping joints has backer plates with sealant; the sealant is split at some coping joints (Photo 20).
- There is a ponding stain on the main roof (Photo 21).
- The longitudinal parapets have a standing seam mansard on the exterior wall side (Photo 22). There is a lower standing seam metal roof at a recess in the building wall (Photo 23).

Photo 16: General view of main roof.

Photo 17: General view of main roof.

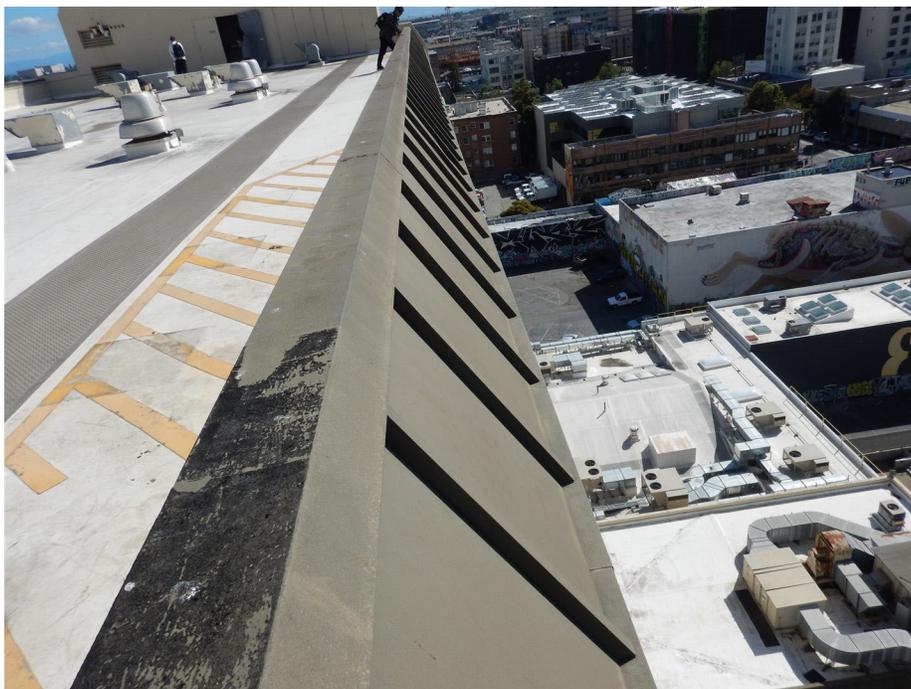
Photo 22: Standing seam metal mansard.

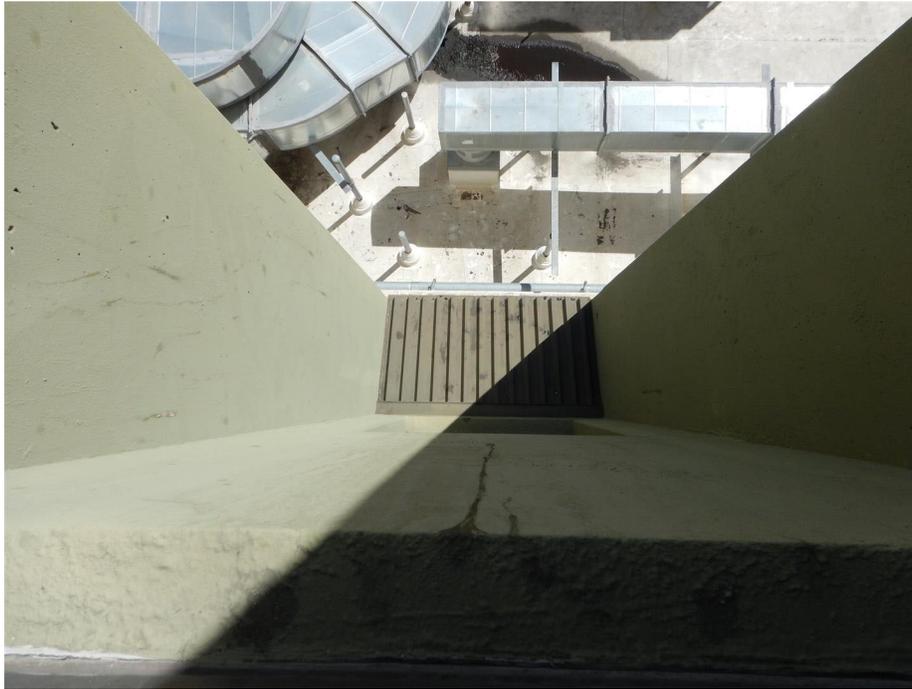
Photo 23: Small standing seam metal roof.

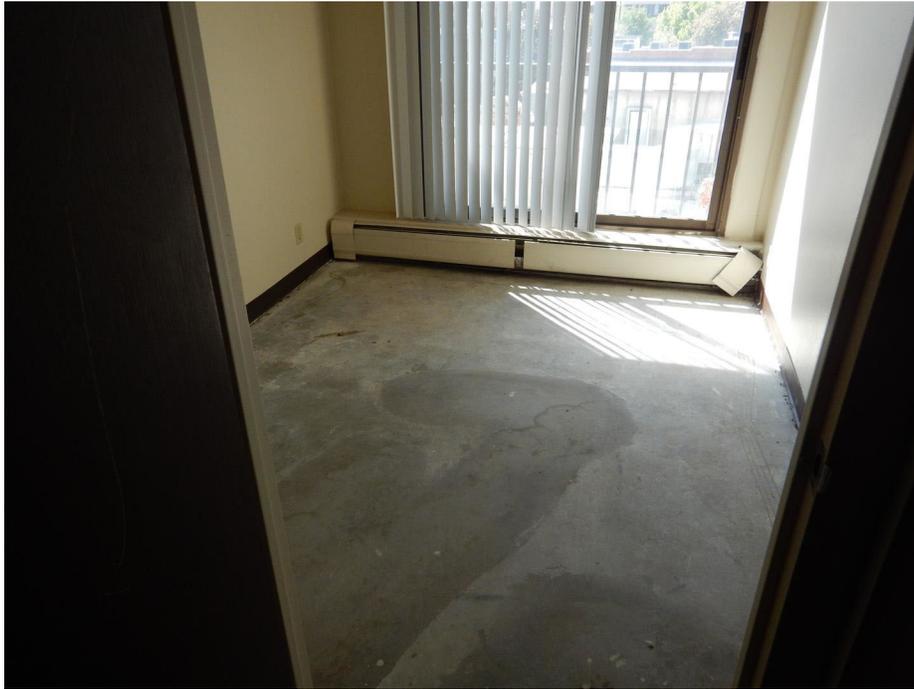
Photo 25: Unit 408 window.

- The aluminum-framed windows have single panes (Photo 24). We accessed the following three units: 408, 503, and 601 (Photos 25, 28 to 30) and observed the interior sides of the windows. We did not see waterstains.
- The corridors have steel-framed windows with wire glass (Photo 26). The sealant is deteriorated at the south-facing Level 4 corridor window (Photo 27).
