IFB #14-011

Roof Replacement for 1621 Harrison Street

Addendum #1

◄◄◄ Roof Condition Summary ▶▶▶▶

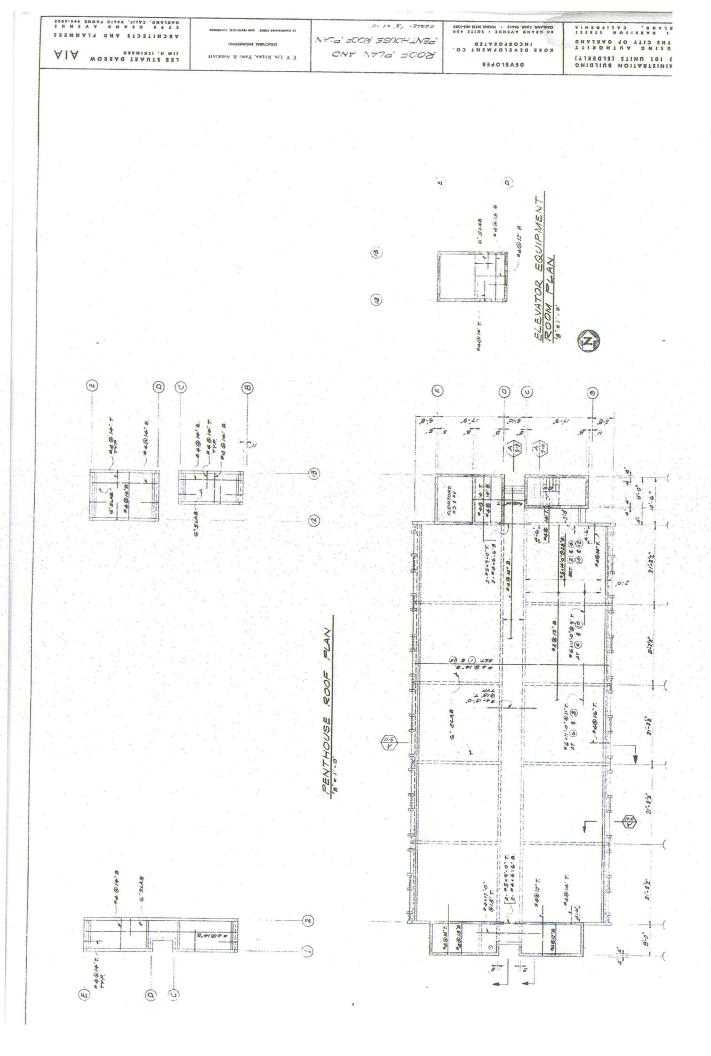
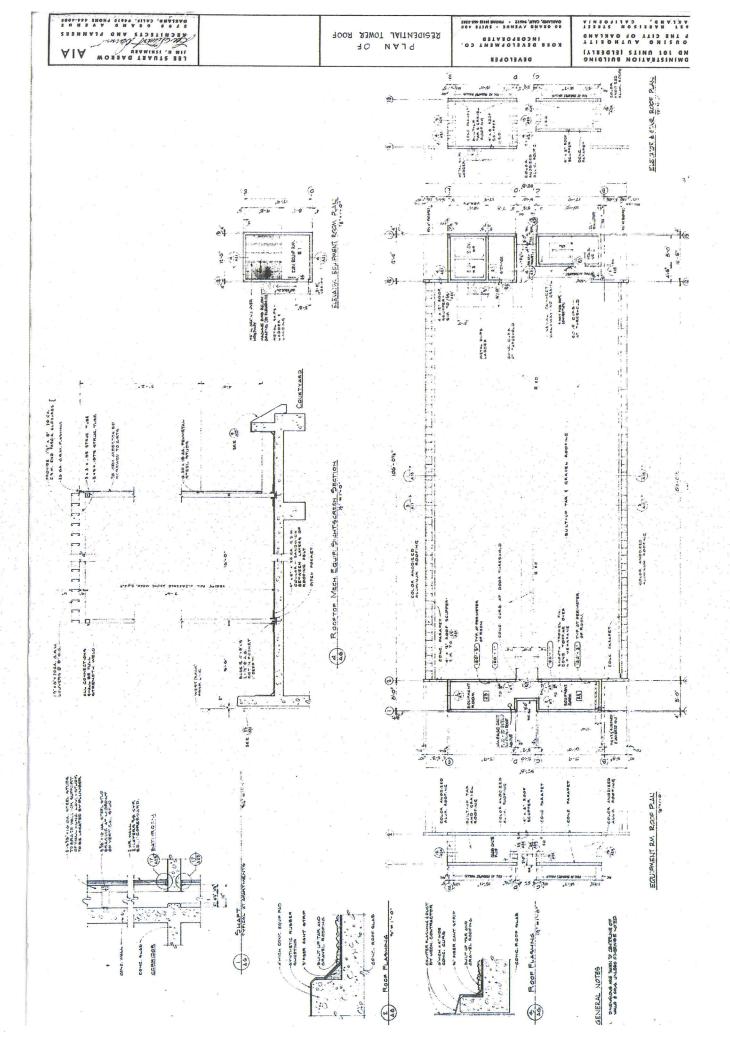
<u>Answer:</u> No. Two roof plans are now being provided, which should provide adequate information to all bidders.

Answer: The existing built-up roof is shown in the attached plans. Please see the Roof Condition Summary attached.
